INSTRUCTION REPORT H-77-1

GUIDELINES FOR MONITORING AND REPORTING DEMONSTRATION PROJECTS

SECTION 32 PROGRAM
STREAMBANK EROSION CONTROL EVALUATION AND
DEMONSTRATION ACT OF 1974

U. S. Army Engineer Waterways Experiment Station
P. O. Box 631, Vicksburg, Miss. 39180

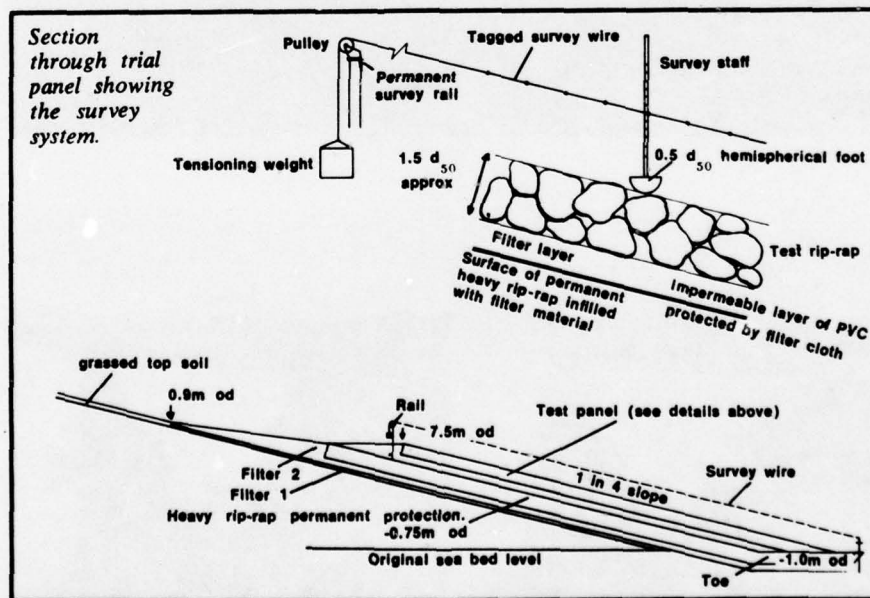
From New Civil Engineer, No. 188, 8 Apr 1976

Winter storms have caused considerable damage to two out of four rip-rap test panels built on the offshore trial bank in the Wash estuary, providing important data for developing a rip-rap design method. The panels were completed last October as part of CIRIA's research into the design of rip-rap protection for reservoirs, barrages and harbour works.

Stone sizes range from 230mm (panel 1) through 400mm and 500mm to 560mm (panel 4). The first panel failed within three weeks, when a two-day storm on 16/17 November caused the largest waves so far recorded at the offshore bank site. The 0.9m-high waves, battering the panels over four tides almost totally destroyed the lightweight protection, washing away the rip-rap and the underlying coarse filter material and ripping holes in the three-layer membrane separating the trial panel from the permanent armouring of the trial bank.

Failure was no surprise to the designers. Stone sizes had been chosen so that panel 1 would be likely to fail within a year, with damage to the remaining panels depending on the hydraulic scale effect that CIRIA is aiming to measure.

Later storms have damaged the second panel (400mm stone), but the location of the damage—adjacent to panel 1—suggests that failure could be due to removal of edge support. Surprisingly, the January storms, which caused massive damage down the East coast, had little effect on the Wash panels. The north facing tail panels escaped the brunt of the storm, partly because the peak of the storm did not coincide with high water and partly because the winds were mainly from the sheltered west face.

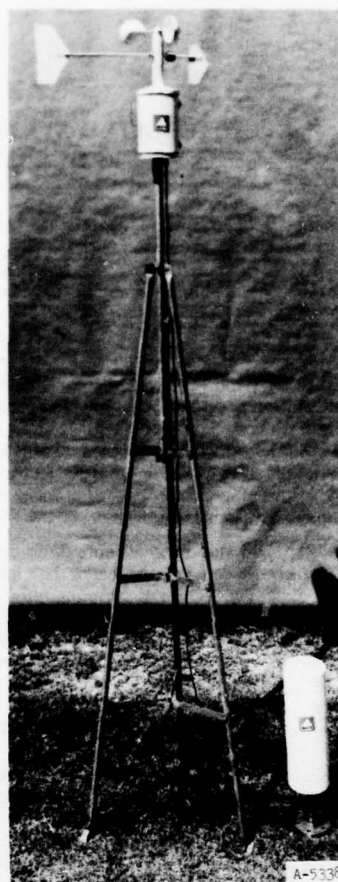
Figure 4. Typical mechanical weather station (sheet 1 of 2)

a. Model 1072

- a. (A3a; B3a; C3a) Weather observations should be obtained close enough to the test site to be reliably representative of conditions at the test site. "Package" weather stations are available commercially (Figure 4). WES has developed an automated environmental data acquisition, handling, and display system (Figure 5) that may be applicable in some of the measuring and recording activities of this project.

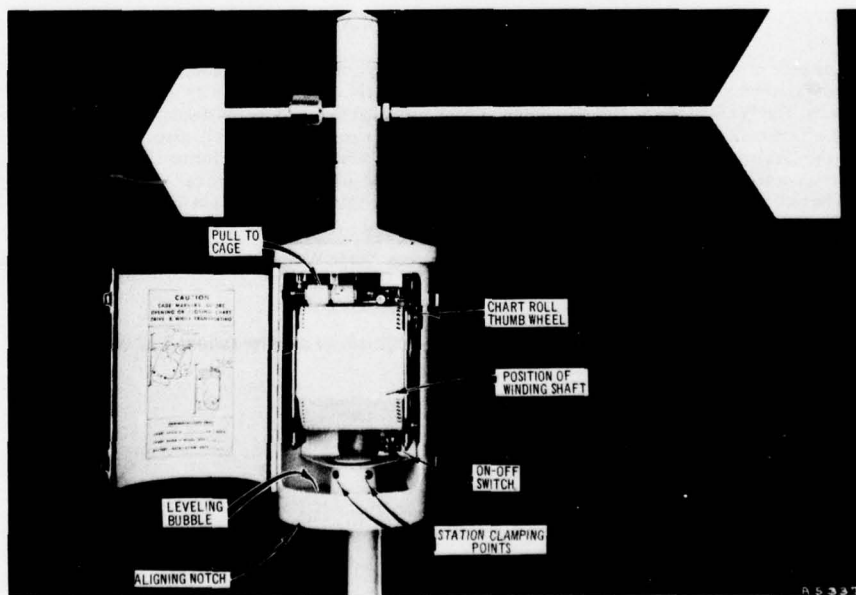
Figure 4. (sheet 2 of 2)

b. Operational view

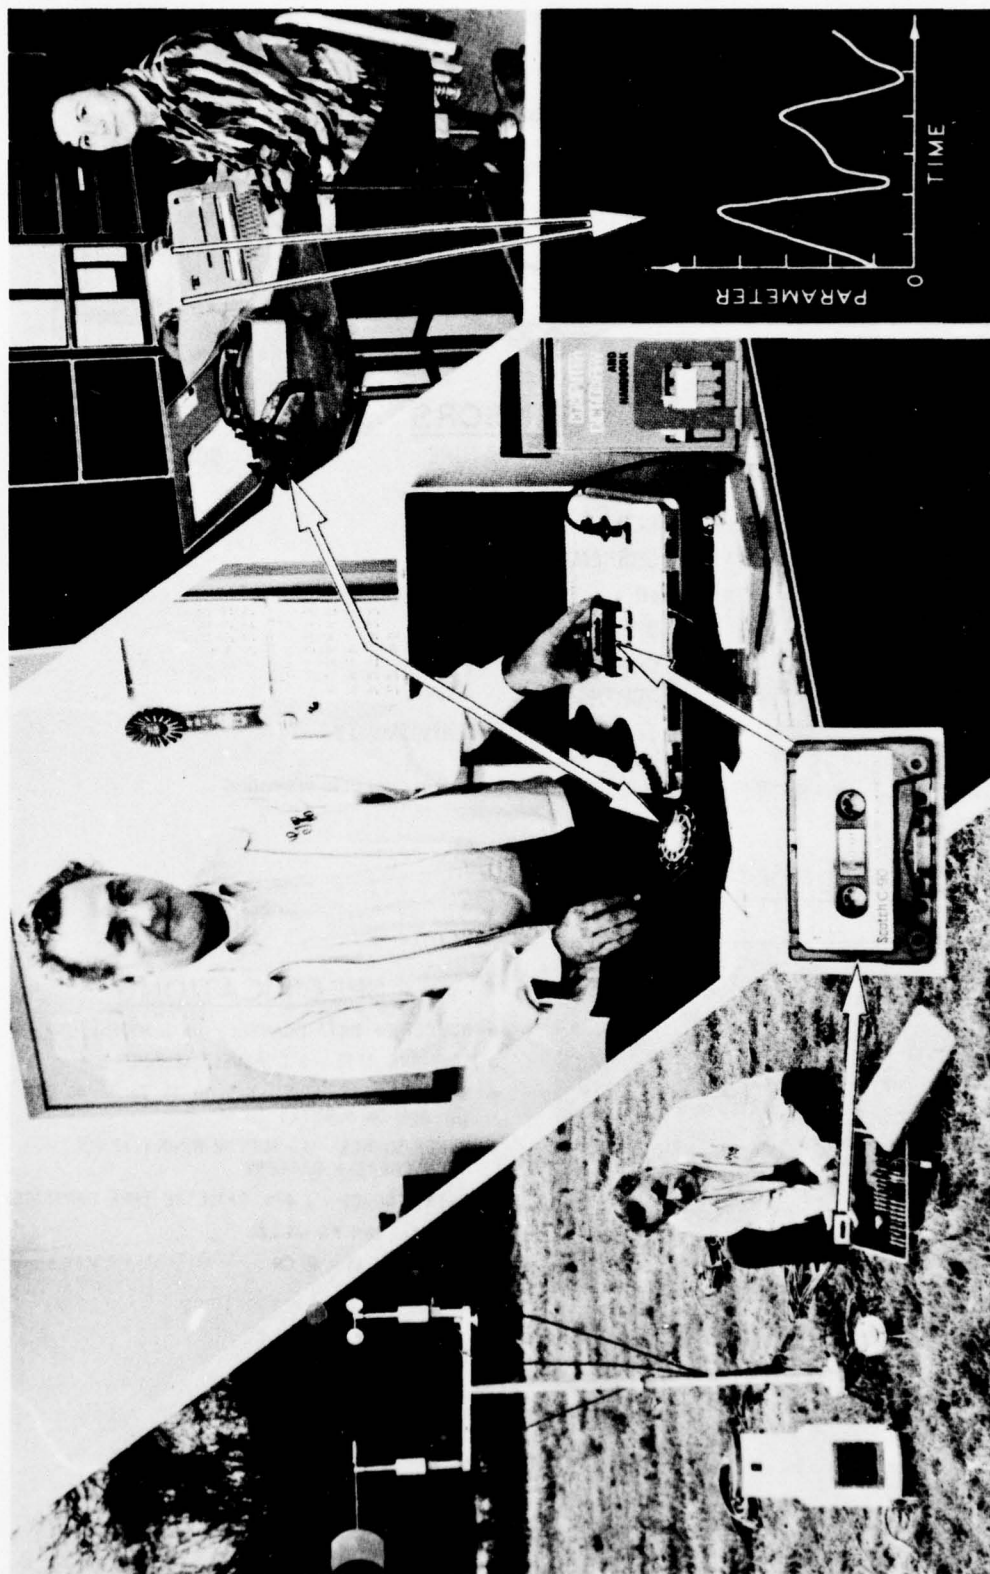
Figure 5. (sheet 2 of 5)

a. Components of automatic environmental data acquisition, handling, and display system

The data acquisition part of the system, a versatile portable field station, consists of a series of sensors and an automatic data recorder. The field station provides for sensing and recording environmental baseline data at sampling rates preselected by the user. Environmental data can be acquired with a variety of presently available sensors providing digital, impedance, or low-level voltaic characteristics. Sensors (b) currently available for establishing environmental baseline conditions include wind speed, wind direction, rainfall, solar radiation (and reflectance), air temperature, soil and water temperature, atmospheric pressure, relative humidity, water stage, water velocity, water depth and the following water-quality parameters: pH, conductivity, dissolved oxygen, and transmissivity.

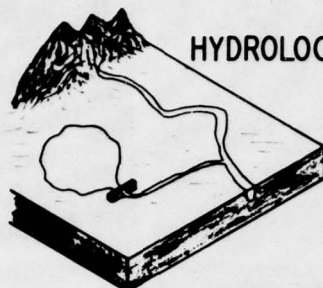
SENSORS

AIR TEMPERATURE
RELATIVE HUMIDITY
SOLAR RADIATION
WIND SPEED
WIND DIRECTION
RAINFALL
BAROMETRIC PRESSURE
EVAPORATION

HYDROLOGICAL

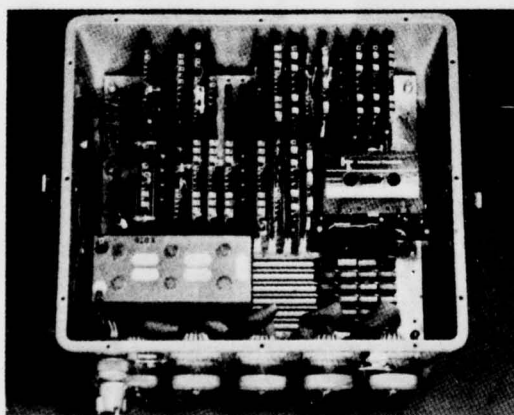
RECORDER

- NUMBER OF DATA CHANNELS (OR SENSORS) - 30
- SAMPLING RATE - 8 CHANNELS/SECOND
- SAMPLING INTERVALS - 3, 5, 10, 15, 20, 30, 40, 60, 120, AND 240 MINUTES
- POWER SOURCE - 4.5 AMPERE HOUR (12 VOLT) RECHARGEABLE BATTERY
- DATA STORAGE - 1 1/4-IN. CASSETTE TAPE CARTRIDGE
- WEIGHT - 10.9 KG (24 LB)
- SIZE - 20 x 40 x 46 CM

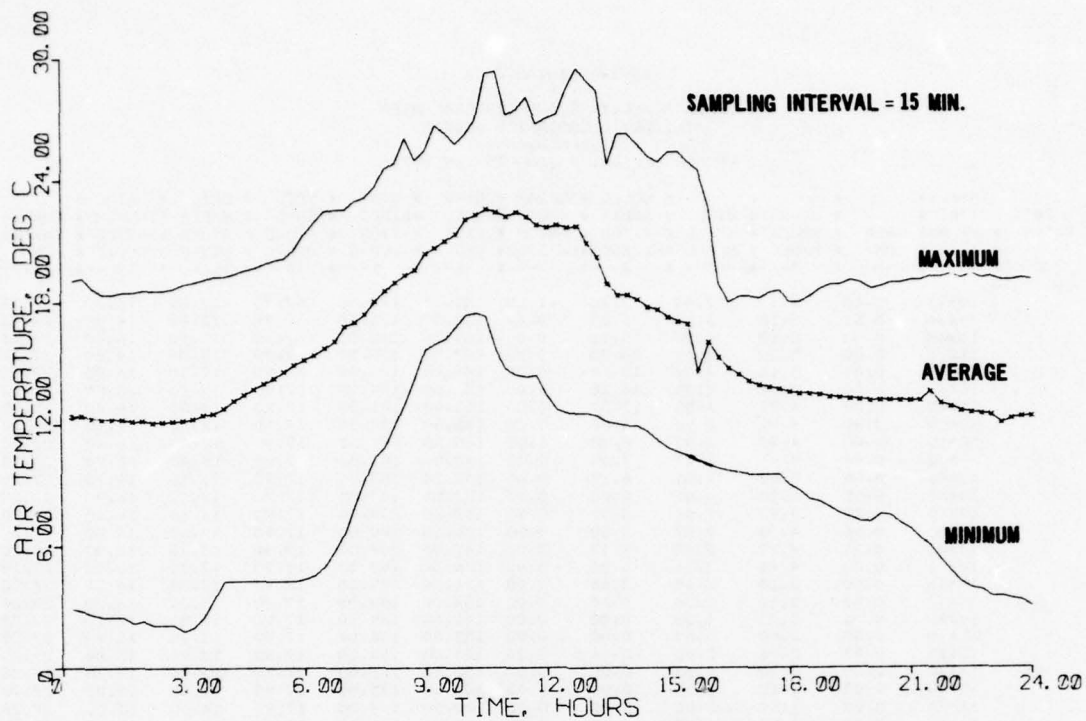
Figure 5. (sheet 4 of 5)

e. Air temperature versus time for a period of 14 days

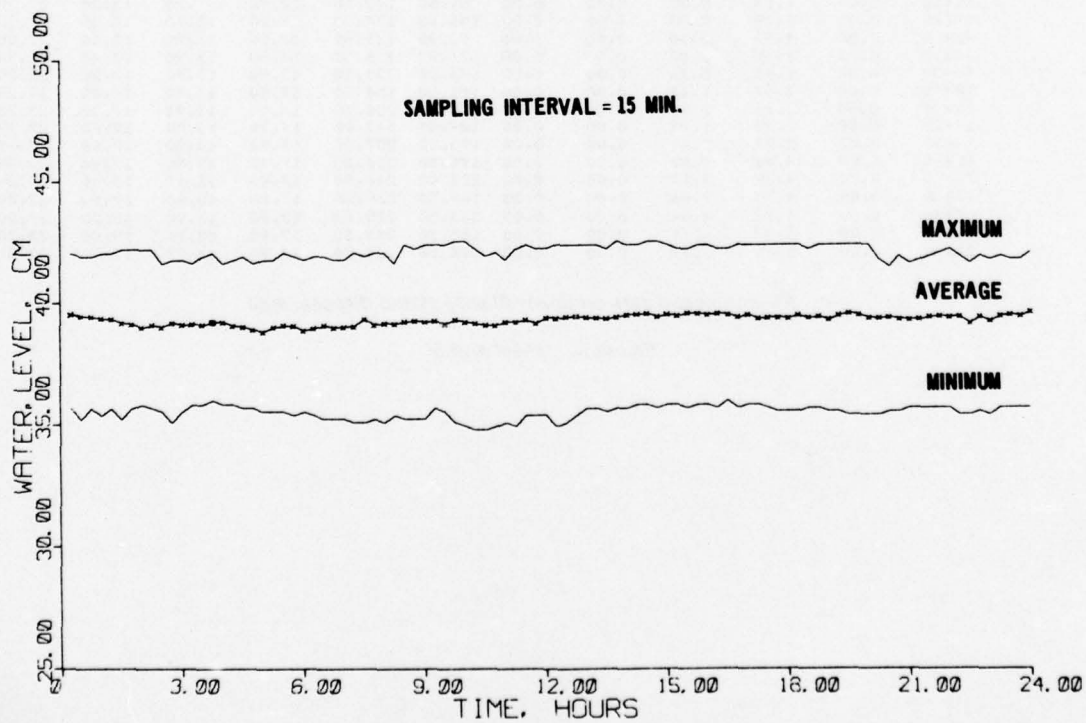
f. Water level versus time for a period of 14 days

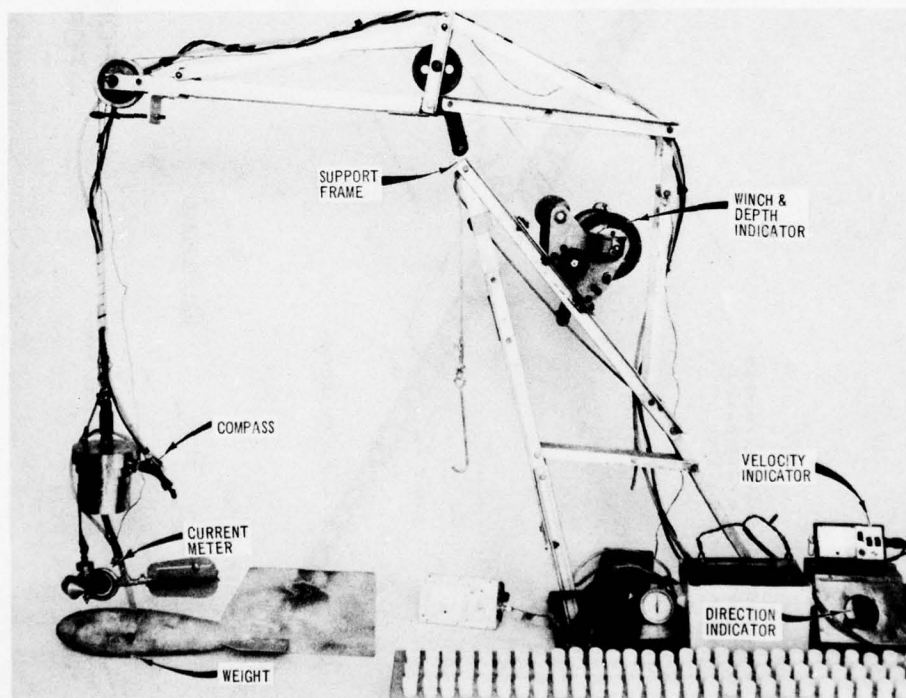
Figure 6. (sheet 3 of 3)

The direction indicator is a remote reading magnesyn compass designed by the WES such that it indicates the magnetic north azimuth of the direction from which the current is flowing. The readout device has a precision of ± 2 deg, but accuracy is dependent upon the balance of the streamlined weight and the strength of current available to turn it. For currents greater than 0.5 fps, the accuracy is ± 10 deg. For lower velocities, accuracy is reduced to ± 25 deg, particularly when waves cause boat motion and when tidal currents slacken and turn.

The winch used to raise and lower the submerged unit operates an indicator that shows the depth of the unit below the water surface. This indicator is used to measure the total water depth and to position the current meter for each reading.

a. Instrumentation for monitoring tidal currents

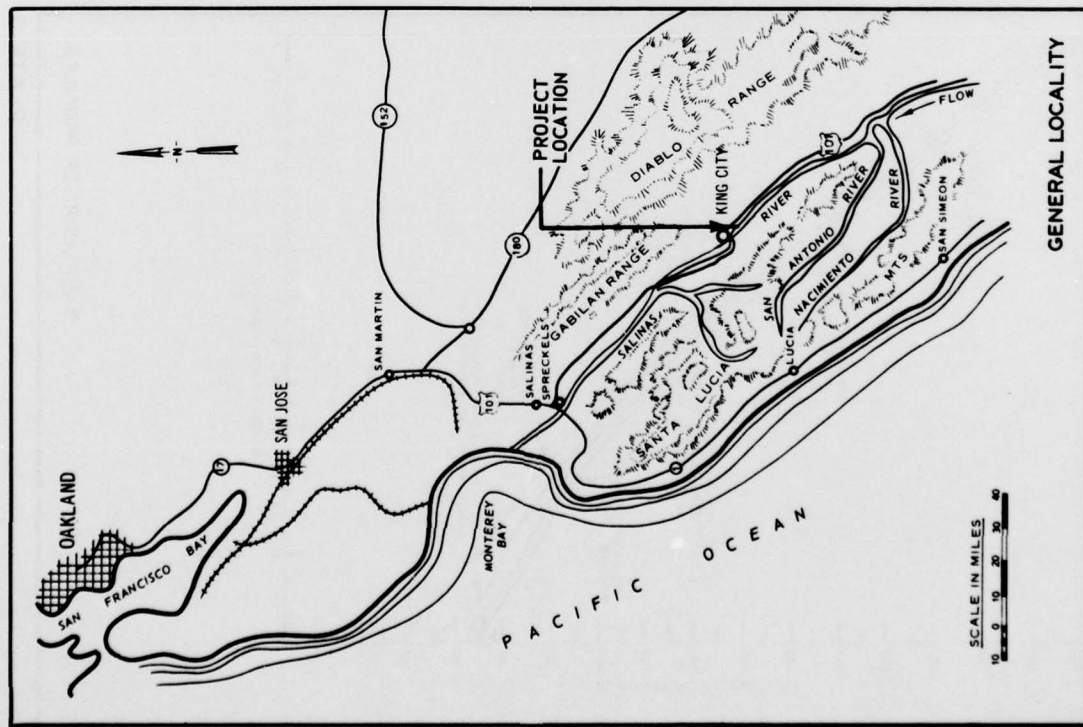
PLATE 1

GENERAL LOCALITY

Gabilan Mountain Range with elevations to 3000 feet. The Salinas River Basin is separated from the Pacific Ocean by the San Lucia Range which reaches elevations approaching 5000 feet (Plate 1). Between the foothills of the mountain ranges, the river flows through relatively level alluvial valley, which is well suited to agriculture. River slopes of the Salinas River vary between 1.0 to 6.0 feet per mile, and the valley floor ranges in elevation from 10 feet near the mouth to 400 feet near King City (Plate 3).

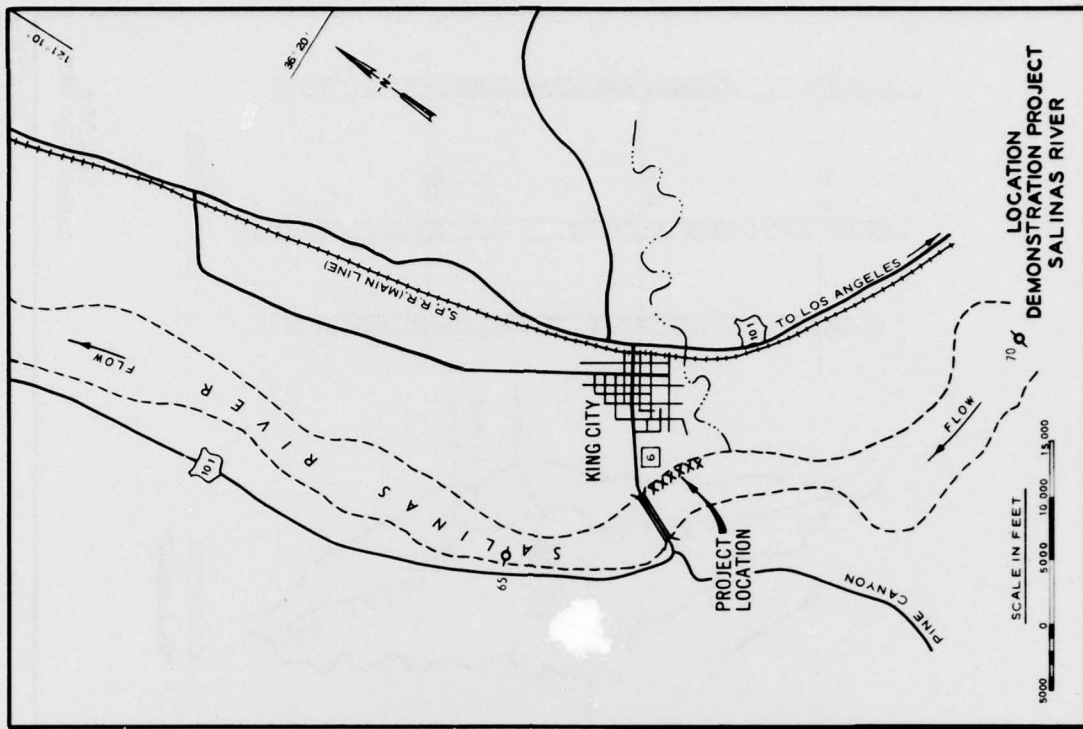
PLATE 2

LOCATION
DEMONSTRATION PROJECT
SALINAS RIVER

4. Problem Résumé. The right bank, upstream of U. S. Highway 101 bridge, was eroding at a rate of 1 to 2 feet per year. The bridge approach was threatened (Plate 2). The high bank land is 40 feet above the streambed and is not subject to inundation. However, it is near the town of King City; and eventually, if urban growth continues, the land could be developed into residential property valued at \$2000 per acre (1977 prices).

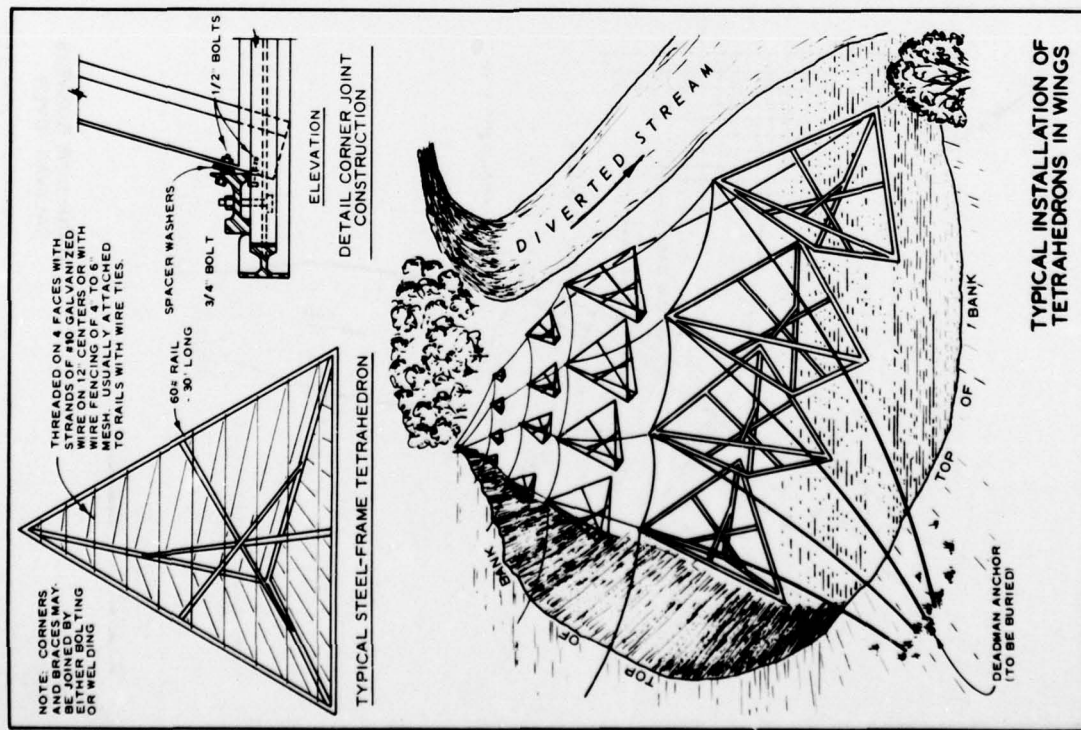
PLATE 11

TYPICAL INSTALLATION OF
TETRAHEDRONS IN WINGS

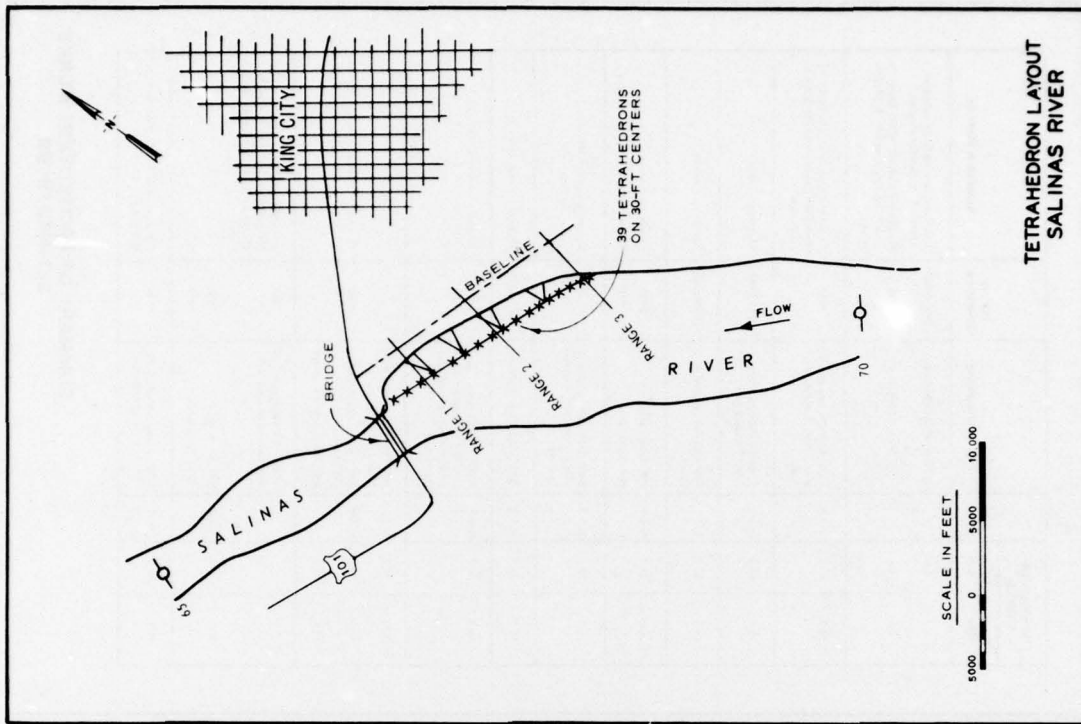
PLATE 12

TETRAHEDRON LAYOUT
SALINAS RIVER

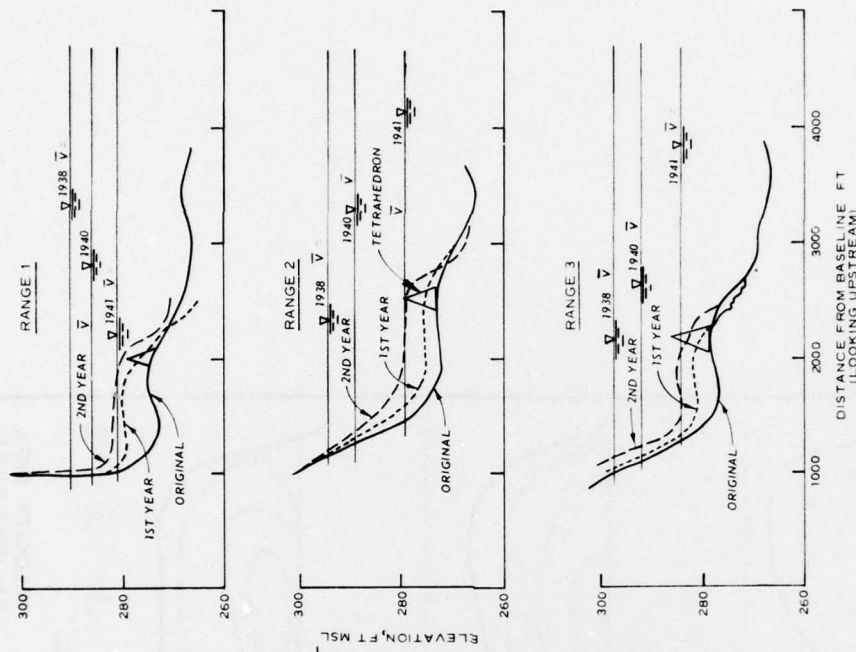
SURVEY OF BANK LINE AFTER HIGH WATER

(3) Bank Erosion Tendencies. The test site (Plate 2) had been eroding at a rate of approximately 1 to 2 feet per year for the past several years. Plate 9 shows the successive bank line as taken from aerial photographs. The flood of record in 1938 caused the most damage with the bank line receding approximately 4 feet during the flood. After, and sometimes during, flood or high water, individual owners have installed revetment works. These revetment works that have been installed over the past three or four decades, have demonstrated a measure of success, and are tabulated in Plate 10.
